# Evaluation of damage mechanics of industrial wind turbine gearboxes

V Jantara Junior, J Zhou, S Roshanmanesh, F Hayati, S Hajjabady, X Y Li, H Dong and M Papaelias

Keywords: wind turbines, gearbox, FEA, condition monitoring, acoustic emission.

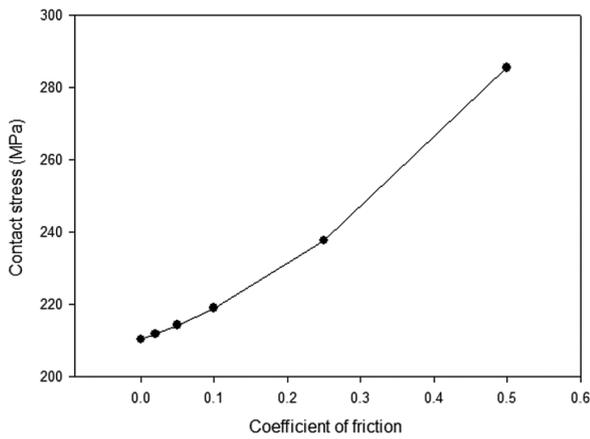
The level of contact stress in relation to the increasing coefficient of friction was modelled for the surfaces of two gear teeth in contact using Abaqus<sup>®</sup>. The plot in Figure 1 shows the results obtained. It can be clearly seen that as the coefficient of friction increases, contact stress also increases due to an increase in the friction force generated at the contact surfaces.

Figure 1. Effect of the coefficient of friction on contact stress

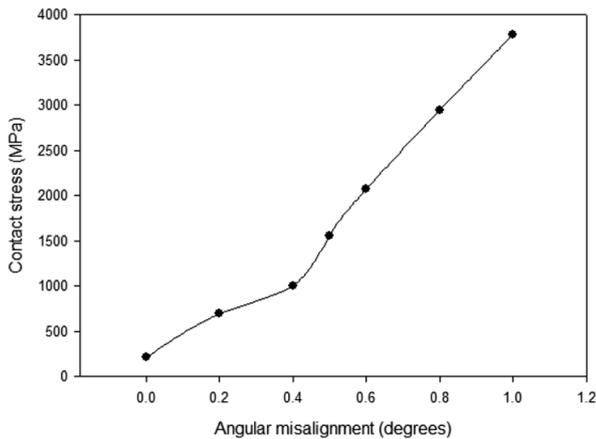
Similarly, in order to test the effect of angular misalignment, one of the gears was rotated along its *y*-axis, between 0° and 1°. The results can be seen in Figure 2. It can be noticed that the angular misalignment has a great effect on the contact stress. Even a small misalignment, such as 0.2°, can produce contact stresses as high as 692.7 MPa, which is almost 3.3 times the contact stress obtained from two gears meshing in perfect alignment.

At 1° of angular misalignment, the contact stress can be almost 18 times higher than the initial contact stress. Such high contact stresses could lead to plastic deformation, eventually causing catastrophic failure of the gear teeth.

Figure 2. Effect of angular misalignment on contact stress

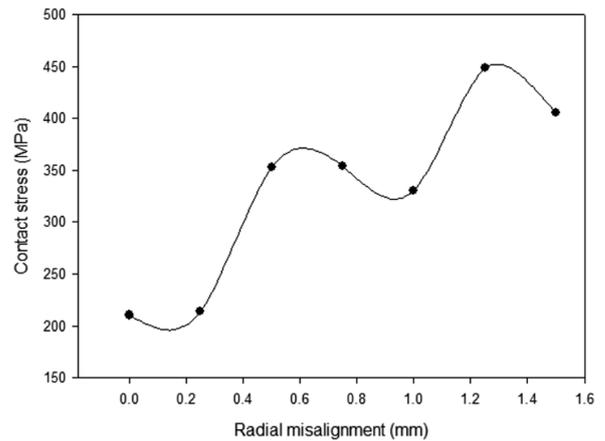
The radial misalignment also increases the contact stress, but not as much as the angular misalignment. As it can be seen, the values obtained for contact stress due to radial misalignment are not linear. However, it is important to notice that any radial misalignment produces a contact stress higher than the contact stress at perfect alignment. The highest stress was observed at a misalignment of 1.25 mm. This is more than double the contact stress during perfect alignment.

Figure 4. Effect of radial misalignment on contact stress

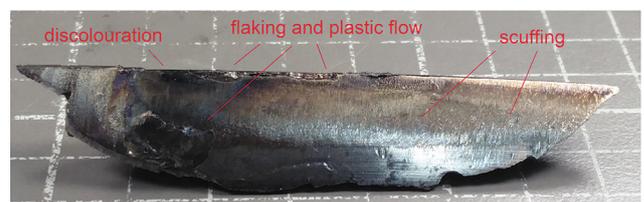
A broken gear tooth from the intermediate stage of a failed wind turbine gearbox was obtained for investigation. Figure 5 shows the flank of the tooth. It is possible to distinguish the occurrence of scuffing, flaking and plastic flow and discolouration.

The discoloured areas are due to overheating caused by lack of lubrication. Scuffing also occurs due to inadequate lubrication and causes local frictional heating at the surface. Flaking, in turn, occurs when cracks in the subsurface of the material propagate to the surface, causing the material to be removed or delaminated.

Figure 5. Side view of the broken tooth retrieved from the gearbox of an industrial wind turbine. Each square measures 1 × 1 cm

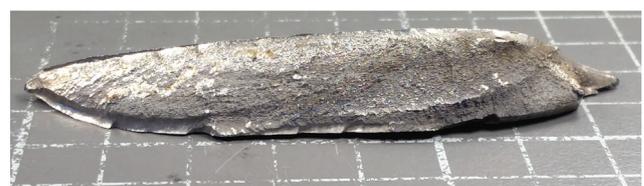
The root of the tooth is shown in Figure 6, where it is possible to see the fractured surface that exhibits typical characteristics of combined fatigue and ductile fracture mechanics. This is confirmed in Figure 7, where a dimpled surface in the fractured area associated with ductile failure due to large plastic deformation is observed. The

Figure 6. Root of broken tooth

This, in turn, increased the stresses at the gear surface, which accelerated the wear and scuffing, with cracks nucleating and propagating from and along MnS inclusions. The new damaged surface created a non-uniform loading distribution, which led to plastic flow and finally ductile failure, as shown earlier in Figure 6.

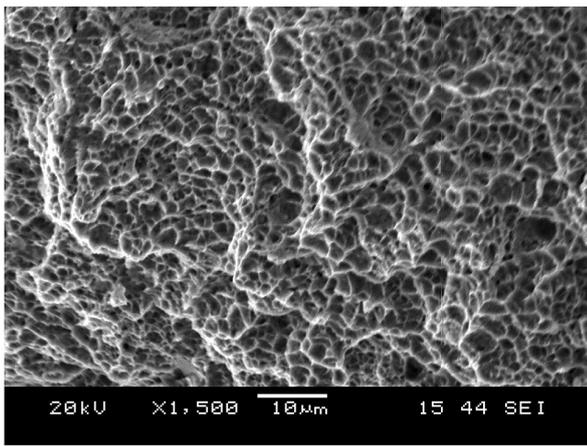
dimples are formed due to the coalescence of microvoids.

Figure 7. SEM image of the root of the broken tooth, showing a dimpled surface with 1500× magnification

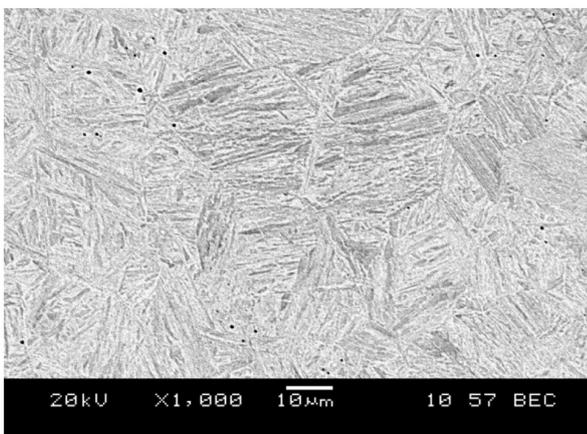
A cross-section of the broken tooth was then cut and prepared for metallographic analysis. Its microstructure predominantly comprises tempered martensite, as shown in Figure 8.

Figure 8. SEM micrograph of the gear tooth showing the tempered martensite microstructure at 1000× magnification

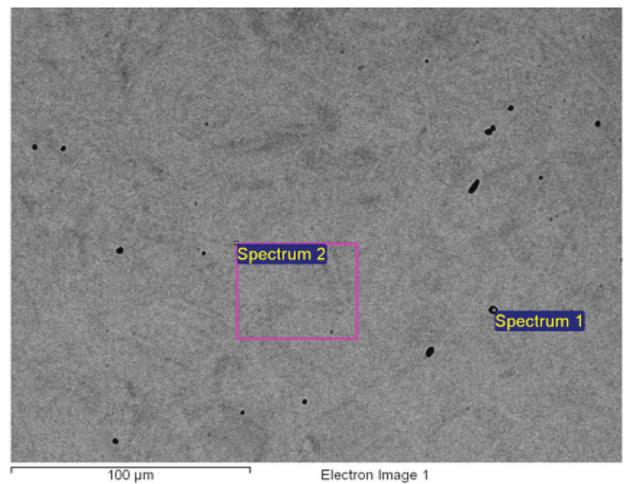
Some inclusions were also found. They were characterised via EDS and found to be MnS, as shown in Figure 9. The analysis revealed Mn, Si, Cr and Ni as alloying elements.

Figure 9. SEM micrograph of the gear tooth EDS results

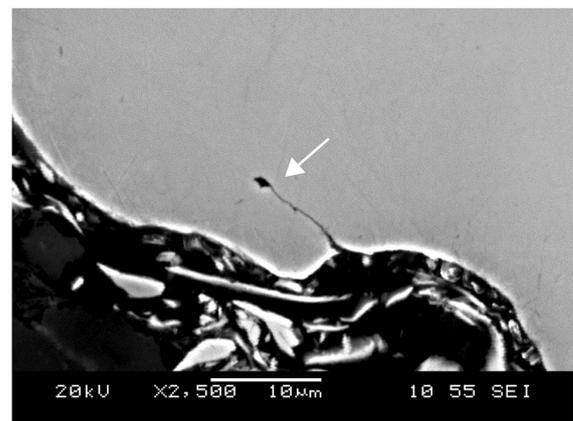
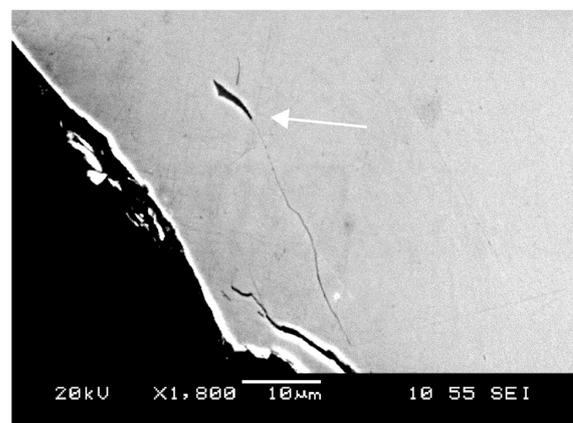
These inclusions found in the microstructure can act as crack initiation points under high contact stress conditions. Several examples of this behaviour were found near the failure area of the gear tooth. Two examples can be seen in Figure 10.

Figure 10. SEM micrographs of MnS inclusions nucleating cracks at (a) 2500× magnification and (b) 1800× magnification

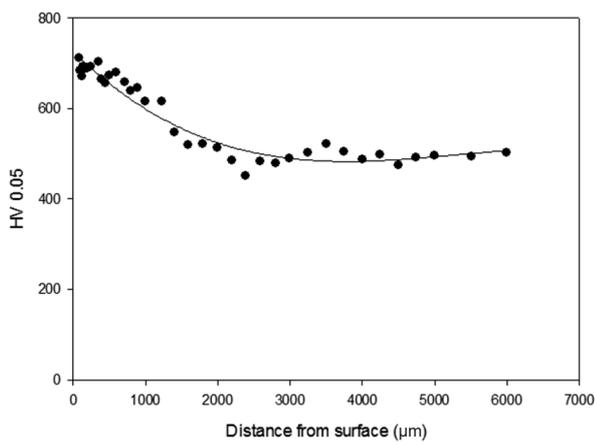
The hardness profile of the gear tooth is shown in Figure 11. The gear is much harder at the case than at the core due to carburisation. The depth of the case is up to 1 mm. The evidence suggests that the primary mode of failure of this gear was caused by lubrication starvation. The lack of lubricant generated scuffing and heating at the tooth surface, while also increasing the frictional forces.

Figure 11. Microhardness profile for the gear tooth
