TECHNICAL REPORT NO. 360

**The Installation of a Digital Autoguider and Tiger Counters in  
Narrabri in 2013 April**

Steven J. Hale and Guy R. Davies

2013 May 20

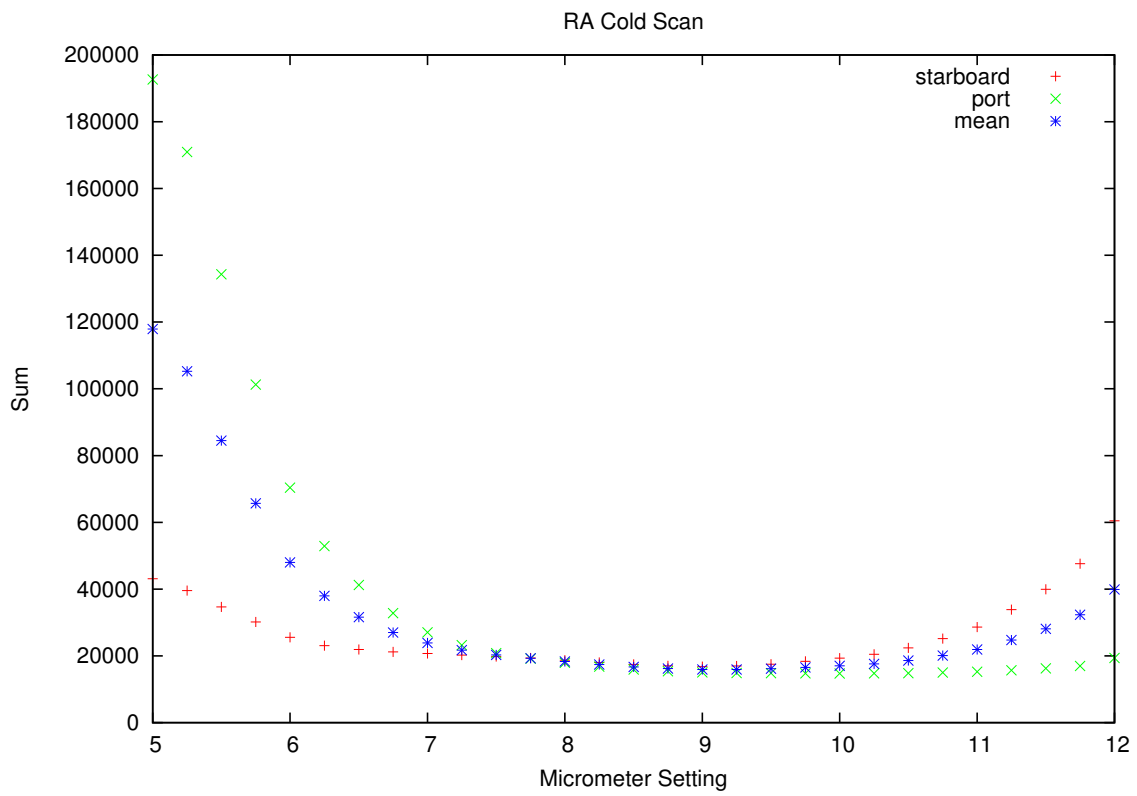
Figure 1: RA Cold.

Four autoguider scans were performed. Both axes were scanned with the potassium cell cold, and then again with the cell hot. The results from the cold scan are shown in figures 1 and 2. The results from the hot scan are shown in figures 3 and 4.

Initially the RA micrometer was set to 9.1 mm and the Dec micrometer set to 8.5 mm. The scans show the ideal alignment to be at RA 9.0 mm and Dec 8.5 mm.

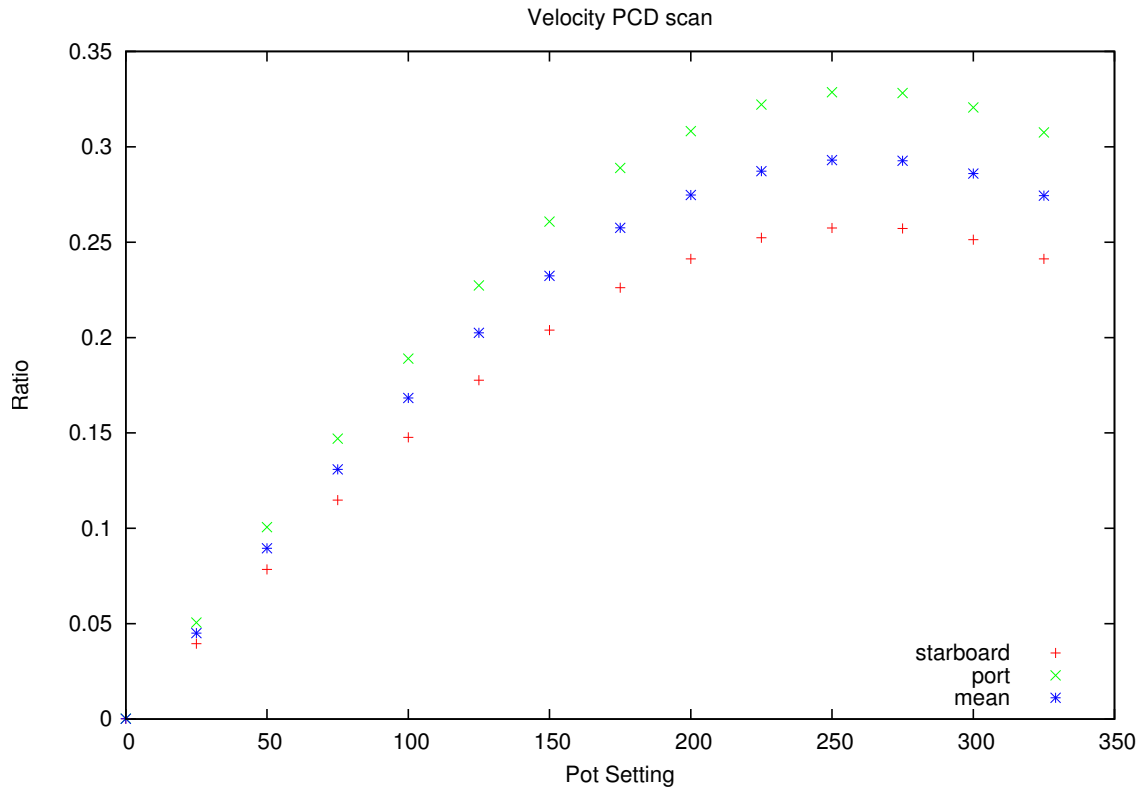
Figure 5: Velocity PCD scan.

The delta-B was disconnected and the magnetic Pockels cell removed. The driver was scanned over the full range while looking at the velocity ratio output from the detectors. The results are in figure 5. The initial setting was “230”, the new scan suggests the best setting is “260” and so the velocity driver was adjusted to the new optimum.

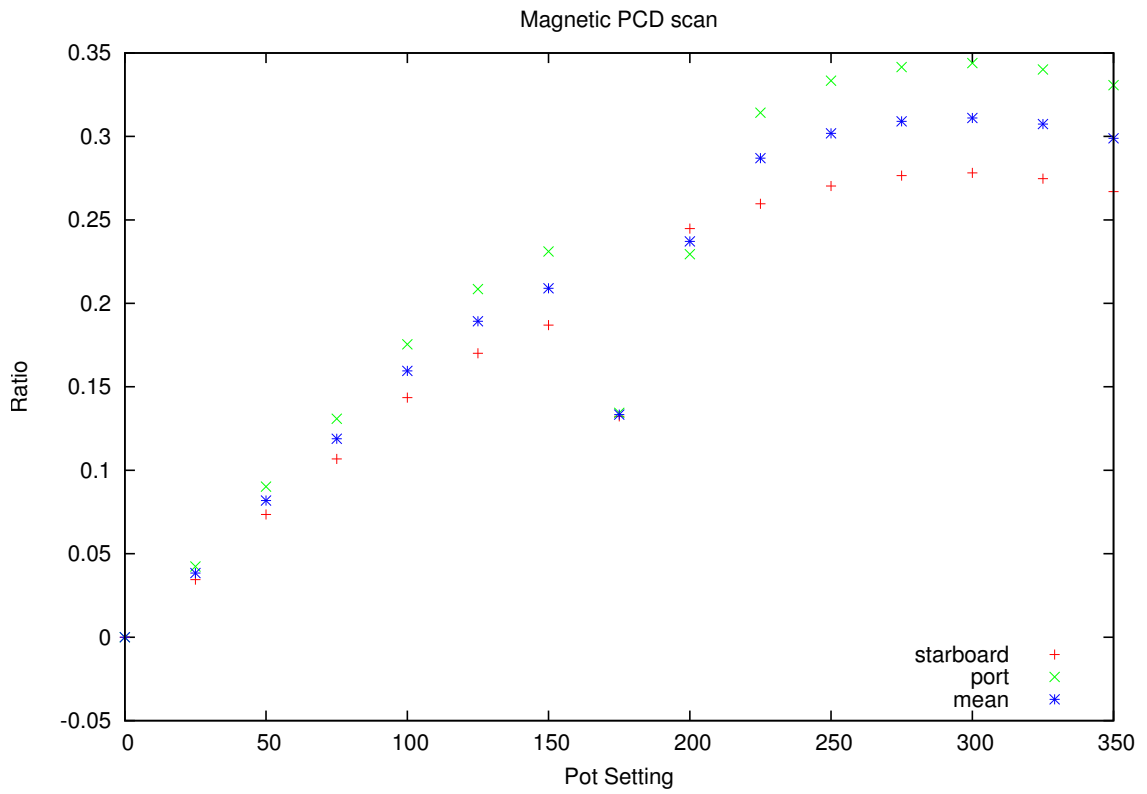
Figure 6: Magnetic PCD scan.

Calibrating the magnetic Pockels cell is slightly more tricky. The magnetic Pockels cell was replaced, and the velocity Pockels cell removed. The magnetic Pockels cell was then moved behind the polariser into the velocity position. The scan was then repeated using the magnetic cell and driver. The results are in figure 6. The initial setting was “250”, the new scan suggests the best setting is “300” and so the magnetic driver was adjusted to the new optimum.

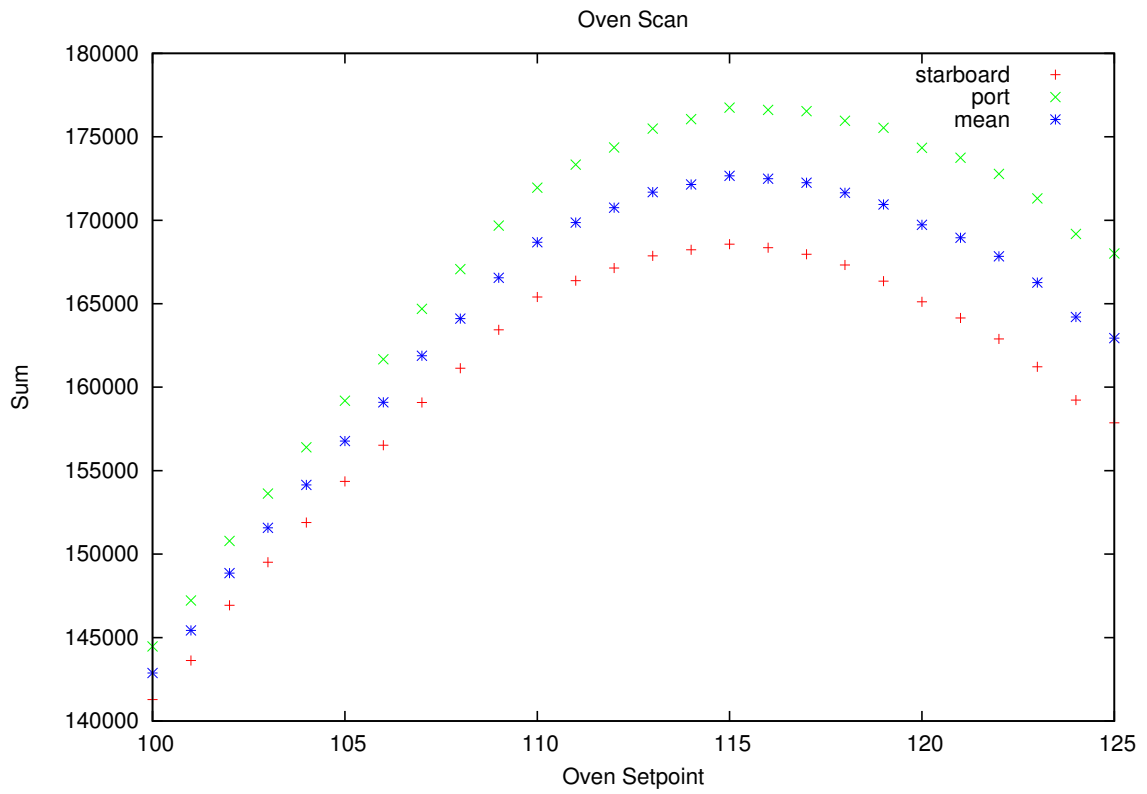
Figure 7: Oven Temperature Scan

The potassium cell was slowly scanned over a range of temperatures. The results are in figure 7. Initially the oven was set to 113 C. The temperature scan shows 115.5 C to be correct, and so the temperature setpoint was updated.
