Framing failures in wood-frame hip roofs under extreme wind loads

Framing Failures in Wood-Frame Hip Roofs under Extreme Wind Loads

Sarah A. Stevenson¹, Gregory A. Kopp^{1*} and Ayman M. El Ansary²

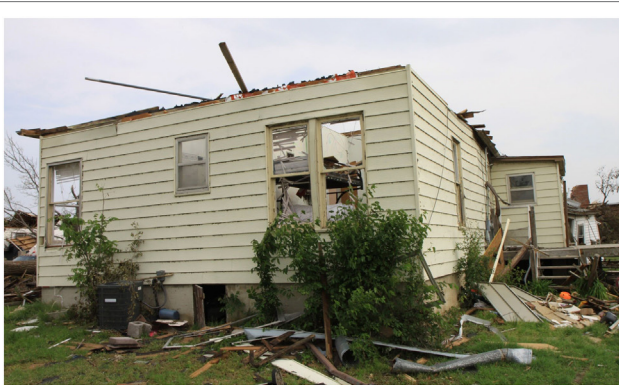
Figure 1 shows an example of typical sheathing failure, and **Figure 2** shows failure of the RTWC. As mentioned, most past research on roof damage focuses on these two failure modes. It is apparent that the wind speed estimates for roof damage in the EF-Scale are heavily based on these well-understood modes. Although DOD-6 encompasses all possible modes of major roof failures, a review of the available literature shows that the current understanding of DOD-6 is limited to research focused on RTWC failures. DOD-6 can occur at an expected wind speed of 122 mph (**Table 1**). This wind speed corresponds to relatively weak EF2 tornadoes (Wind Science and Engineering Centre, 2006). DOD-4 occurs at lower wind speeds. Gable roofs have been observed to

FIGURE 2 | Example of roof-to-wall-connection failure, corresponding to DOD-6 (image source: Dr. David Prevatt).

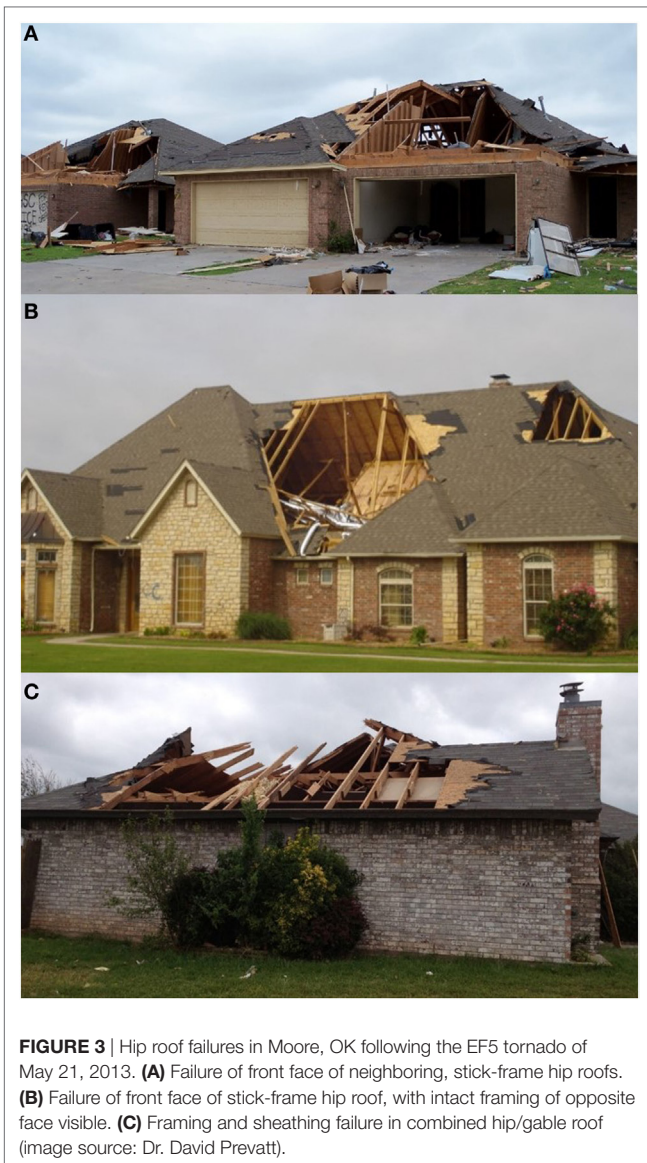
Figure 3A shows neighboring hip-roofed homes that exhibit similar failures of the front face of the roof. The RTWCs appear to be intact around the remaining perimeter of the roof and it is apparent that several members of the roof frame have failed or been removed, in addition to the sheathing covering this portion. At the right side of the photo, the remaining part of the roof is sagging, which further indicates that the underlying frame has failed. The houses shown in **Figure 3A** were located along Kyle Drive at the western edge of Moore, OK. Several houses along this short stretch had similar failures of hip roof framing and were built around 2006 (Graettinger et al., 2014). Inspection of the damage photos from this neighborhood indicate that, of houses experiencing DOD-4 or DOD-6 roof damage, 40% appeared to have failed through similar partial failures. In these cases, it appears that the frame failed at the nailed connections between the members, as no broken lumber is visible. The following section will present additional statistics and observations from two selected neighborhoods following the Joplin, MO tornado.

Figure 3B shows a failure similar to that in **Figure 3A**, but of a much steeper roof. The RTWCs appear to be intact, and a large open cavity is visible where both framing members and sheathing have been removed. Similar to **Figure 3A**, it is apparent that this roof did not exclusively suffer sheathing loss, although the smaller area of sheathing loss at the right side of the photo should be noted. The lack of visible internal members in the cavity, especially those supporting the intact opposite face of the roof, strongly suggest that this roof was built as a stick-frame structure as opposed to the one containing prefabricated trusses. Many of the failed hip roofs in the available data appear to have used stick framing.

Figure 3C shows a partial failure of a combined hip/gable roof. This failure is unique from those shown in **Figures 3A,B** because material failure of the wood members is apparent. The RTWCs appear to be intact, with the lower part of the

roof having lost only sheathing on the right side and framing members, in addition to sheathing, on the left. Near the peak of the roof, the frame has failed on both faces. This structure appears to contain either trusses or stick framing with robust connections. As indicated in the figure just above the RTWC, the members were connected or otherwise reinforced using nailed wooden plates.

Upon inspection of the failures shown in **Figure 3** and similar damage in the available photos, it becomes apparent that partial framing failures are possible, repetitive modes of failure occurring in hip roofs. When comparing these hip roof failures to nearby structures from the data, it was determined that framing failures may govern in some hip roofs at EF2 wind speeds, rather than RTWC failures or sheathing loss. It is also noted that the construction of the roof may be important. The observed stick-frame failures especially suggested that the performance of stick-frame roofs should be distinguished from that of trussed structures in analysis and design, as well as in the present research.

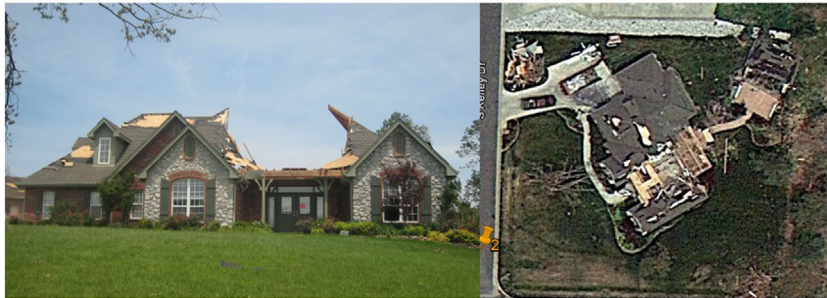
of failure of the RTWC. **Figure 5** shows an example of the steep-sloping hip roofs visible throughout this neighborhood, with an aerial image showing how the surface area of the roof was affected by the failure. In many instances, the largest surfaces of the roof were removed, while parts of the structure enclosing smaller spaces remained in place. Many of these structures also appeared to be of stick-frame construction.

FIGURE 5 | Example of typical hip roof failure in Region 1, including an aerial photo showing the footprint of the partial failure (image source: Dr. David Prevatt, Google Earth).
