TECHNICAL REPORT NO. 303

## The Replacement of the Shaft Couplers in Las Campanas in 2008 March

2008 April 23

All shaft couplers were replaced. The front filter mounts on both instruments were replaced and the alignment checked.

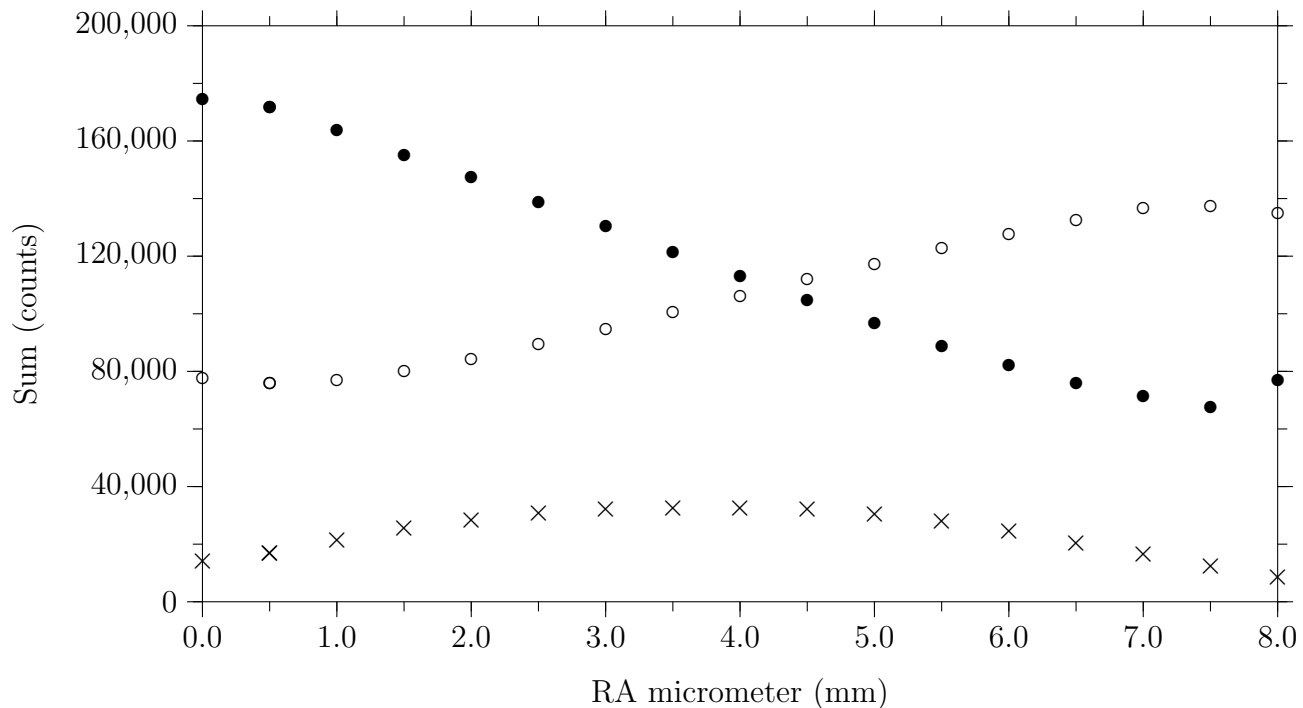
Two autoguider scans were performed on March 20 in order to check the alignment of the mount. The results of the right-ascension scan are shown in Figures 1 and 2. It looks like Hannibal is centered when the right-ascension micrometer is set to 4.25 mm and Ivan is centered at 3.25 mm. A compromise of 4.0 mm seems to be the best, slightly favouring Hannibal the primary instrument. The initial setting was in fact 4.0 mm and so no improvement was made here.

**Figure 1:** RA scan (Hannibal) - The guider was scanned right ascension. The plot shows how the starboard sum (●), port sum (○), and the transmission monitor (×) varied. This scan was done with the declination micrometer set at 2.25 mm and the cell hot.

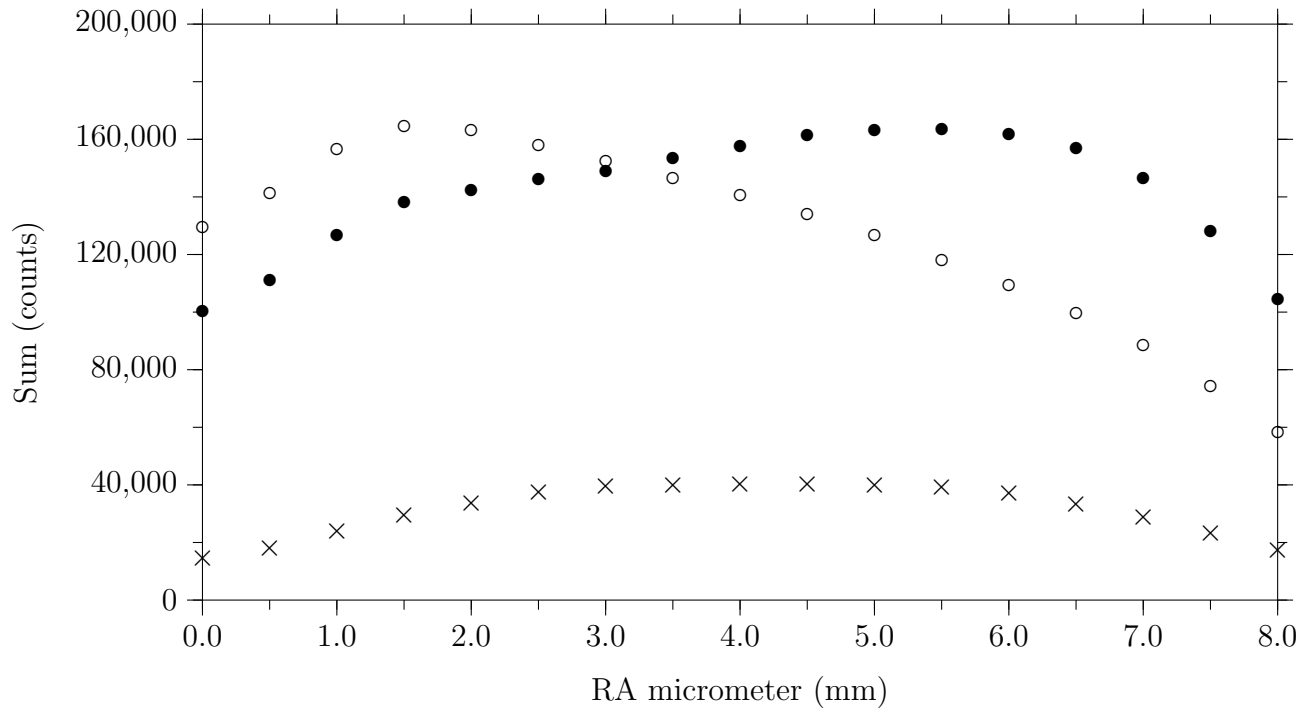
**Figure 2:** RA scan (Ivan) - The guider was scanned right ascension. The plot shows how the starboard sum (●), port sum (○), and the transmission monitor (×) varied. The transmission monitor data have been divided by ten. This scan was done with the declination micrometer set at 2.25 mm and the cell hot.

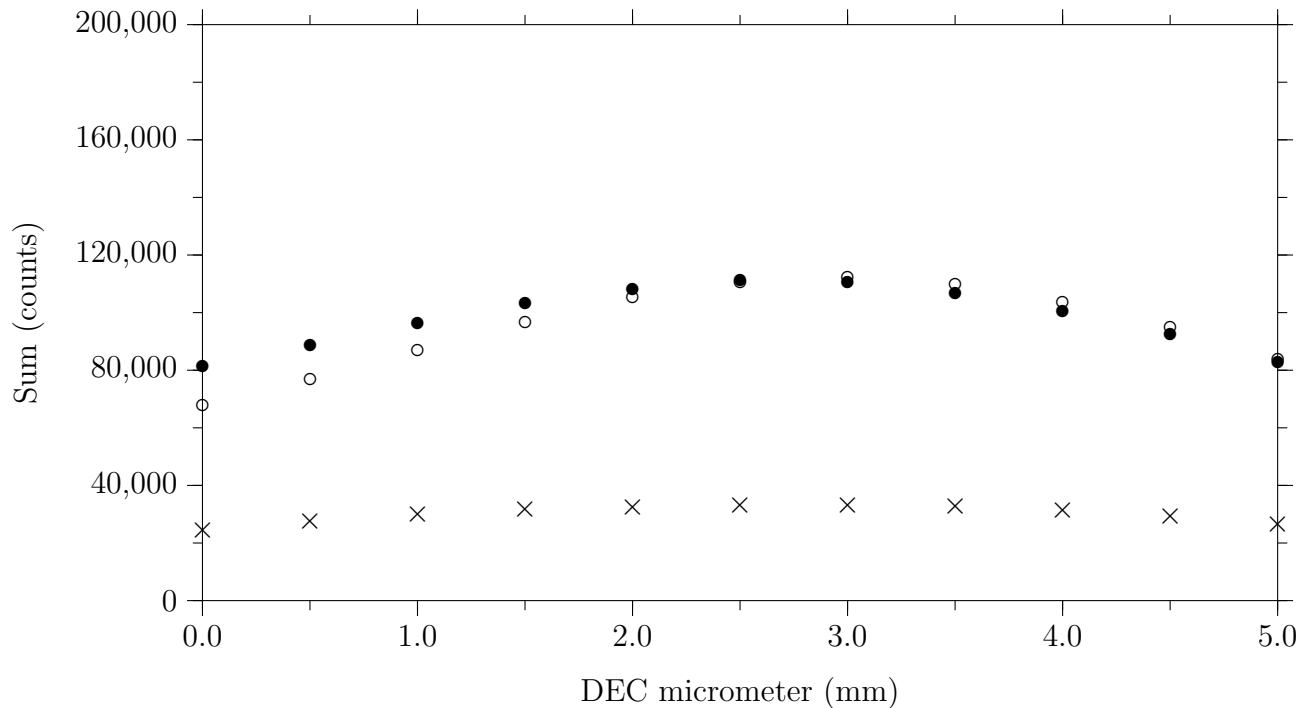
The results of the declination scan are shown in Figures 3 and 4. It looks like Hannibal wants the declination micrometer set to 2.5 mm while Ivan wants 1.5 mm. The best compromise here seems to be a setting of 2.0 mm. The initial setting was 2.25 mm and so a slight improvement was made.

**Figure 3:** DEC scan (Hannibal) - The guider was scanned declination. The plot shows how the starboard sum (●), port sum (○), and the transmission monitor (×) varied. This scan was done with the right ascension micrometer set at 4.0 mm and the cell hot.

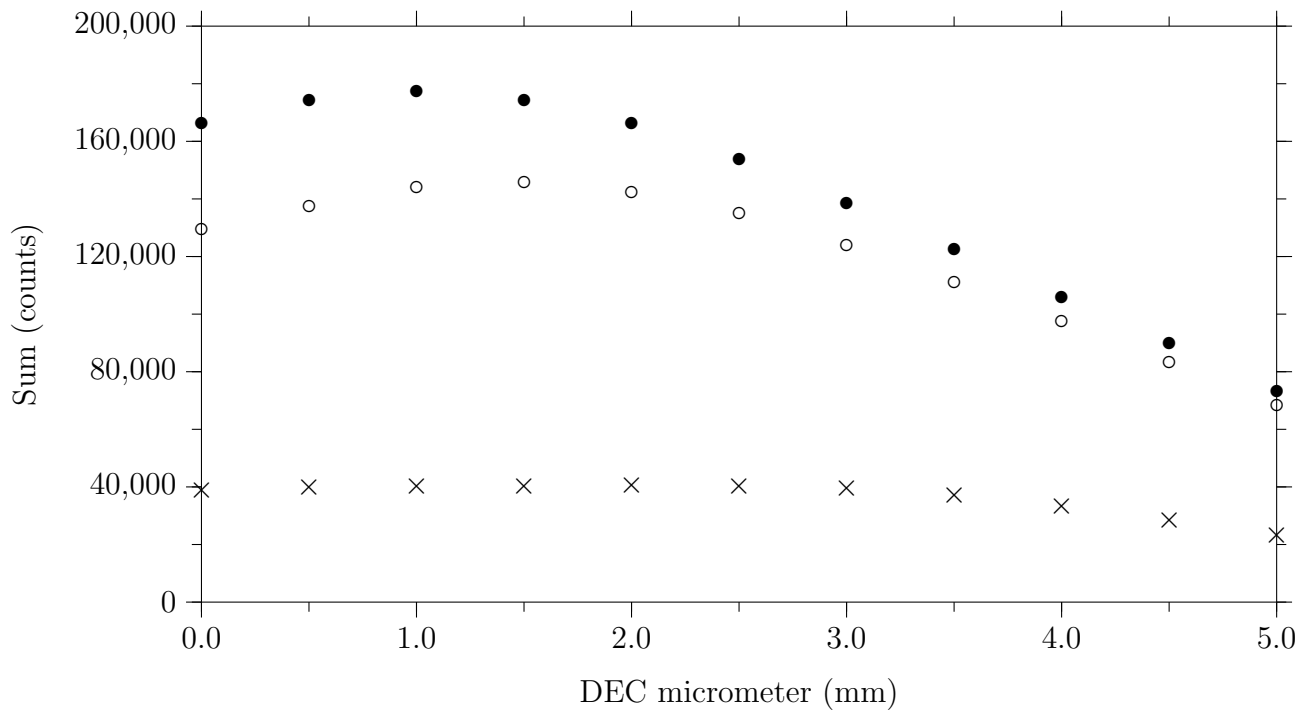
**Figure 4:** DEC scan (Ivan) - The guider was scanned declination. The plot shows how the starboard sum (●), port sum (○), and the transmission monitor (×) varied. The transmission monitor data have been divided by ten. This scan was done with the right ascension micrometer set at 4.0 mm and the cell hot.
