2nd CIRP Conference on Surface Integrity (CSI)

The effect of cutting speed and feed rate on hole surface integrity in single-shot drilling of metallic-composite stacks

Abstract

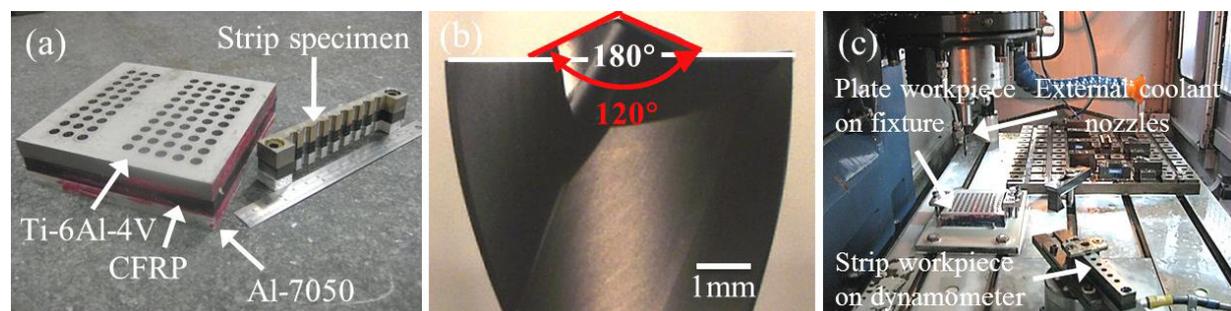
Fig. 1. (a) Ti/CFRP/Al stacks; (b) CVD diamond coated drill; (c) experimental setup

Al-7050-T7651 aluminium alloy. The Ti workpieces were supplied in the annealed condition with yield strength and Young's modulus of 880MPa and 114GPa respectively [13]. The CFRP laminates were composed of 36 unidirectional plies (each 0.18mm thick) involving high tensile strength (HTS-268-12K) carbon fibres pre-impregnated (pre-pregs) within an epoxy based matrix laid up according to an orientation of $[45^\circ/0^\circ/135^\circ/90^\circ/45^\circ/0^\circ]_{3S}$. This resulted in a fibre volume fraction of 56% giving a tensile strength of 1200MPa and Young's modulus of 145GPa [14]. In contrast, the Al alloy was age strengthened to provide a yield strength and Young's modulus of 550MPa and 72GPa respectively [15]. The individual workpiece materials had dimensions of 120×120mm and were bonded together (in the order of Ti/CFRP/Al) using a thermosetting modified epoxy film adhesive. The overall stack thickness was 27mm. Thin strip workpiece samples (120×17×27mm) joined using two M6 screws were also employed at intervals for force measurement and subsequently cross-sectioned for surface integrity investigation, see Fig. 1(a). The drills evaluated (recommended by tool supplier) were 6.38mm diameter CVD diamond coated WC with a two-stage point angle of $120^\circ \times 180^\circ$, helix angle of 30° and relief angle of 14° ; see Fig. 1(b). Table 1 details the mechanical/physical properties of the CVD diamond coating.

All experiments were undertaken on a Matsuura FX-5 CNC machining centre with a maximum spindle rotational speed of 20000rpm rated at 15kW, see Fig. 1(c) for the test setup. Preliminary tests (Tests 1 and 2) involving feed rates of 0.08 and 0.15mm/rev were initially performed with a cutting speed set of 30/120/120m/min (Ti/CFRP/Al). These values were subsequently increased by 20% to 36/144/144m/min with further trials undertaken at 3 different feed rate levels of 0.05, 0.08 and 0.12mm/rev, see Table 2 for test array. A water-miscible emulsion with a 7-8% volume solution of mineral oil was utilised in all tests, which was delivered via external coolant nozzles at a fixed pressure of 70 bar and flow rate of ~ 47 l/min.

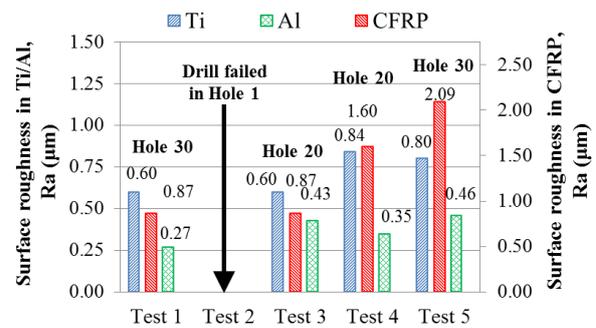
maximum flank wear criterion. Fig. 2 details surface roughness results measured at the last hole drilled for all tests. Under the low speed/intermediate feed rate regime (Test 1), average hole roughness in the Ti, CFRP and Al sections at test cessation was 0.60, 0.87 and 0.27 μ m Ra respectively. Equivalent values for the Ti and CFRP layers were obtained in Test 3 after 20 holes, when operating at the higher cutting speed of 36/144/144 m/min and lower feed rate of 0.05mm/rev. The Ra in the Al section however was ~ 59% higher.

Fig. 2. Hole surface roughness in each material at last hole drilled

Increasing feed rate from 0.05 to 0.12mm/rev (at 36/144/144 m/min cutting speed) led to a ~ 140% rise in average hole surface roughness within the CFRP section, which was ~ 2.09 μ m Ra in Test 5 at hole 30. In terms of the Ti layer, roughness was 40% higher when operating at 0.08mm/rev compared to 0.05mm/rev, but remained approximately stable despite a further increase in feed rate to 0.12mm/rev. In contrast, no clear trend was apparent in the Al sections due to changes in feed rate, with the surface roughness varying between 0.35 and 0.46 μ m Ra.

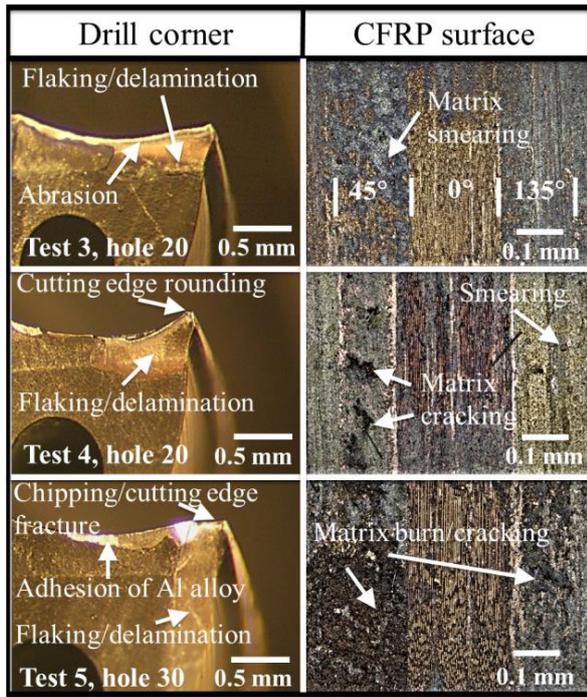
The principal wear mode of the drills was flaking/delamination of the CVD diamond coating, irrespective of operating parameters. This was observed primarily on the tool flank face near the peripheral corners as well as at the chisel point. Micrographs of the worn CVD diamond coated drills for trials undertaken at the higher cutting speed level (Tests 3, 4, 5) together with corresponding hole surfaces in the CFRP section of the stack are shown in Fig. 3. Rapid abrasion of the exposed WC substrate was also prevalent in all tests, which increased cutting edge rounding and the corner radius of the drill. Wear was generally more severe at higher feed rates, with gross fracture of the chisel point occurring in Test 4 (0.08mm/rev) and chipping/fracture of the peripheral corner in Test 5 (0.12mm/rev). No significant wear/damage however was seen at the chisel section of the drill employed in Test 5 even after 30 holes, see Fig. 4, which was possibly due to the shorter tool-workpiece interaction time. Evidence of workpiece adhesion on the cutting edges was however visible.

Fig. 3. Wear micrographs of drill corner and corresponding CFRP surface at last hole drilled in Tests 3, 4 and 5

Smearing of melted epoxy resin was the primary damage mode observed on the surface of the CFRP layer after 20 holes when drilling with the lowest feed rate of 0.05mm/rev, see Fig. 3. Greater deterioration of the workpiece surface occurred as feed rate increased, with matrix cracking and burning evident in the last holes drilled for Tests 4 and 5 respectively, which explains the surface roughness results detailed previously in Fig. 2. This was possibly due to the higher cutting temperatures generated from the increased feed rate and tool wear levels. No signs of grooves or significant material loss however were detected in any of the samples evaluated. In addition, defects were generally most severe in the 135° ply positions, as shown in the high resolution SEM micrograph and corresponding 3D topographic map (1.25 x 0.5mm scan area near the centre of the hole) of the machined surface (hole 30, Test 5) in Fig. 5.

Fig. 7(a) and 7(b) detail cross-sectional micrographs of the machined Ti and Al subsurface respectively from the last hole drilled in Test 5. No appreciable change in material microstructure was visible in both workpiece samples, despite chipping of the peripheral drill corner (Fig. 3). This was representative of results seen in the other trials.

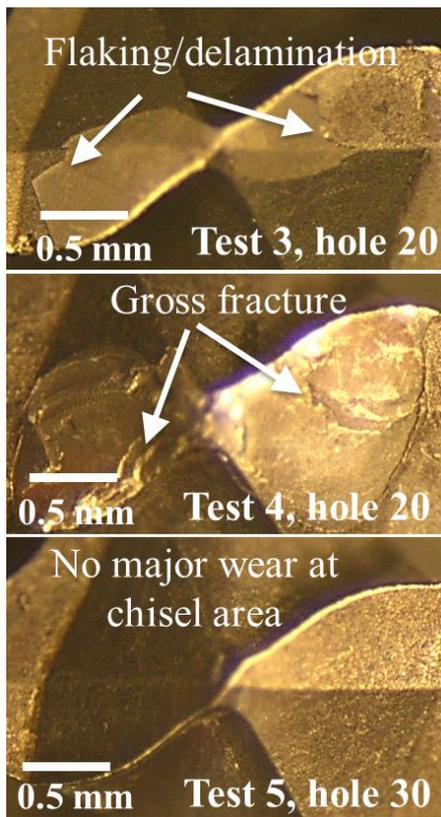
Fig. 4. Micrographs of worn drill chisel section in Tests 3, 4 and 5

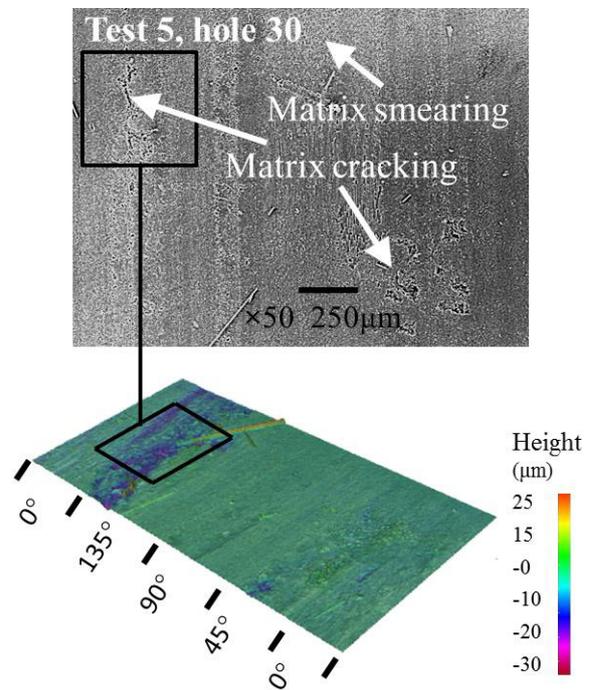
Fig. 5. SEM micrograph and 3D topographic map of CFRP hole surface in Test 5

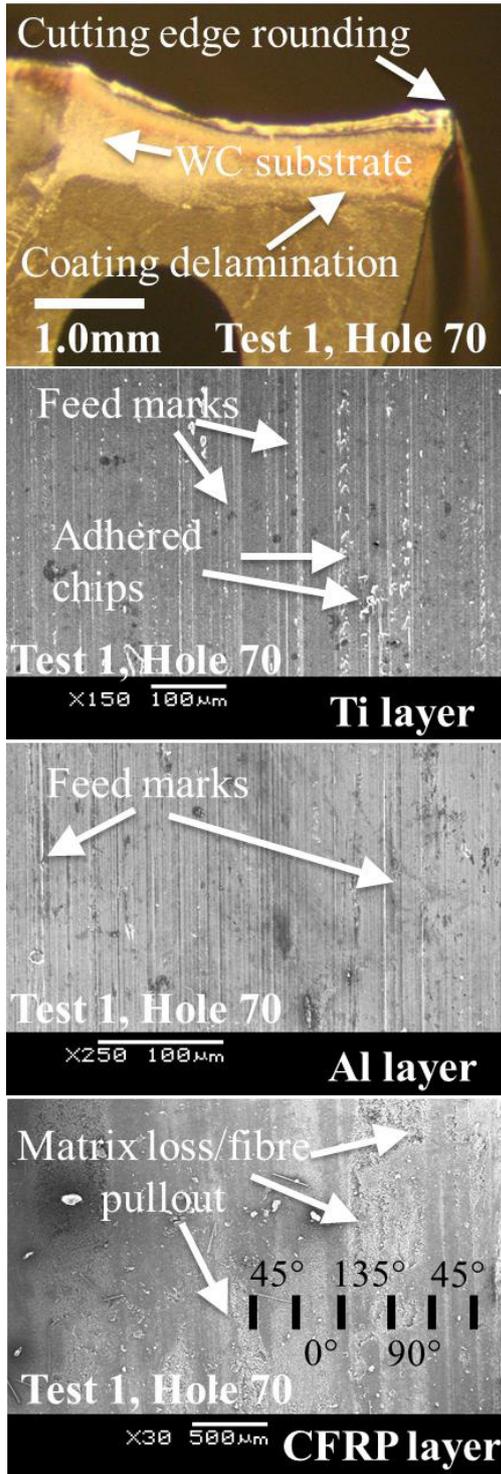
Test 1 was subsequently extended to 70 holes in order to investigate drill wear progression and its consequent influence on workpiece integrity. Fig 6 shows a micrograph of the drill after hole 70 together with associated SEM images of the machined surfaces in each material layer. Flank wear increased to ~ 1mm with near complete delamination of the coating from the cutting edge. Evidence of sporadic re-deposited chips was seen on the surface of the Ti layer while the Al section appeared to be relatively free of major flaws. In contrast, the highly worn drill caused substantial degradation of

the CFRP surface, with gross fibre loss and matrix pullout particularly at the 45°, 90° and 135° orientated plies.

Fig. 6. Wear micrograph of the drill used in Test 1 and SEM images of the machined surfaces in each layer of the stack in hole 70

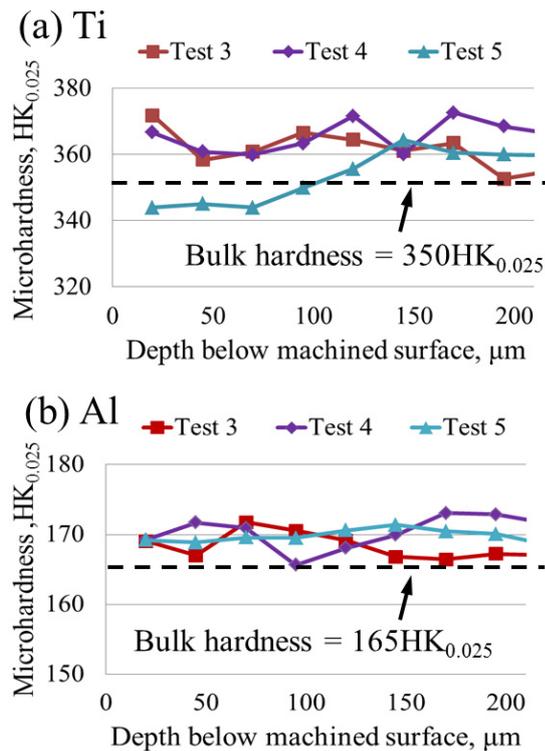
Fig. 8 details microhardness depth profiles of both the Ti and Al layers at the last hole drilled for Tests 3, 4 and 5 (cutting speed of 36/144/144m/min). No significant variation in microhardness was observed for the Ti layer in any of the trials evaluated; see Fig 8(a). This was despite measured thrust forces showing a rise of ~ 41% (~690 vs. 980N) as feed rate was increased from 0.05 to 0.12 mm/rev. Corresponding torque values ranged between ~2.3 and 3.6Nm at test cessation. Similarly, an analysis of the Al sections revealed no substantial changes in subsurface microhardness due to changes in feed rate; see Fig. 8(b). Here, thrust forces and torque for the last hole drilled varied from ~278 to 410N and ~0.75 to 1.3Nm respectively, as feed rate increased from 0.05 to 0.12mm/rev. The results suggest that neither strain hardening nor thermal softening played a major role.

Fig. 8. Microhardness depth profile at test cessation when drilling at 36/144/144m/min cutting speed in (a) Ti; (b) Al layers
