Automated detection of cracks in roads using ground penetrating radar

Eskandari Torbaghan, Mehran; Li, Wenda; Metje, Nicole; Burrow, Michael; Chapman, David; Rogers, Chris

Eskandari Torbaghan, M, Li, W, Metje, N, Burrow, M, Chapman, D & Rogers, C 2020, 'Automated detection of cracks in roads using ground penetrating radar', *Journal of Applied Geophysics*, vol. 179, 104118. <https://doi.org/10.1016/j.jappgeo.2020.104118>

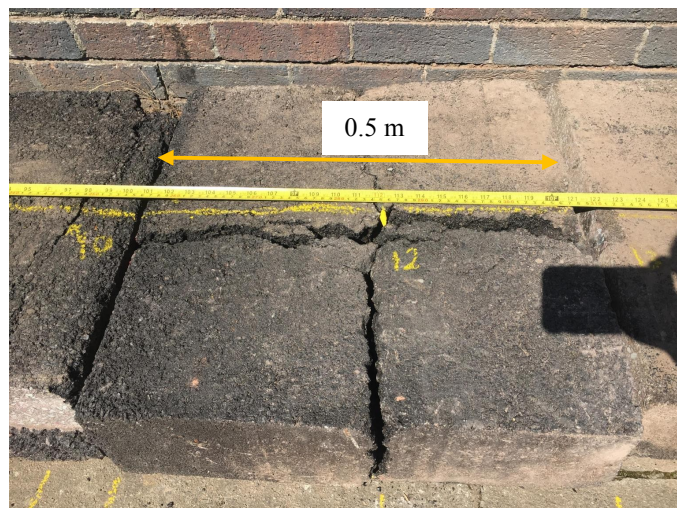
Figure 2: One of the tested asphalt slabs

penetrated the surface and the crack depth was 110 mm throughout. An example of the resulting cracked asphalt pavement is shown in Figure 2.
