Online condition monitoring of rolling stock wheels and axle bearings

Mayorkinos Papaelias^{1*}, Arash Amini¹, Zheng Huang¹, Patrick Vallely^{1,2}, Daniel Cardoso Dias³ and Spyridon Kerkyras⁴

Abstract

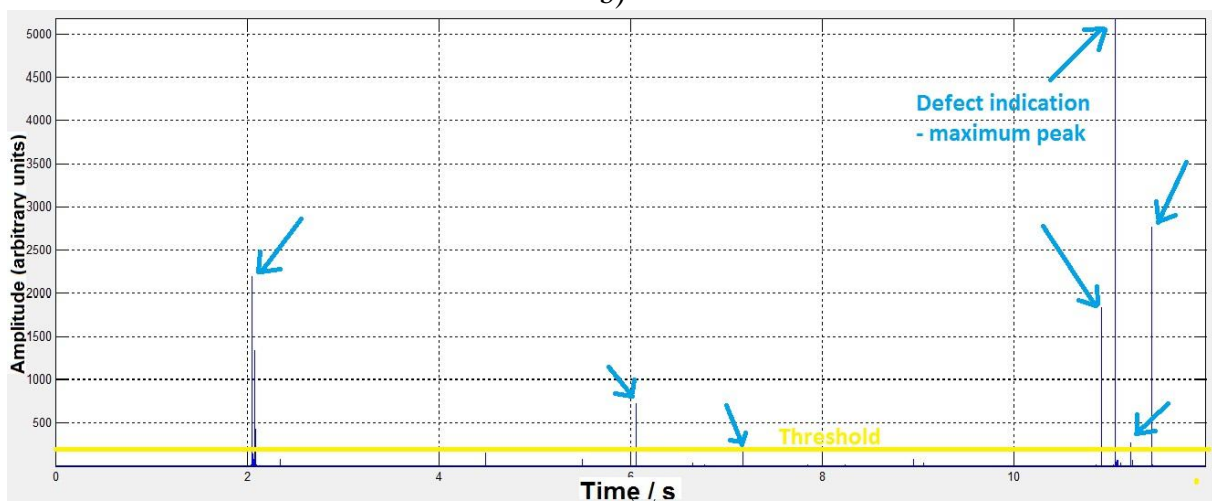
Figure 11: a) Raw AE data acquired from a bearing with a 8 mm roller defect and b) RMS processed results. Notice the amplitude of the strong RMS peaks which is much higher than the RMS for the 4mm roller.

Figure 11a presents the raw AE data and 11b the moving RMS from an 8mm roller defect. Note the increasing maximum peak amplitude (~5100 arbitrary units) of the RMS signal indicating the higher severity. However, the variability in each axle bearing rotation remains with some of the peaks falling even below the threshold limit despite the much higher amplitudes recorded in the raw signal. This is another indication that the amplitude is not sufficient indicator and the energy the signal carries need to be considered. Also in order to safely assess the severity of the signal we need to trend the maxima from several measurements in order to reach a reliable conclusion.

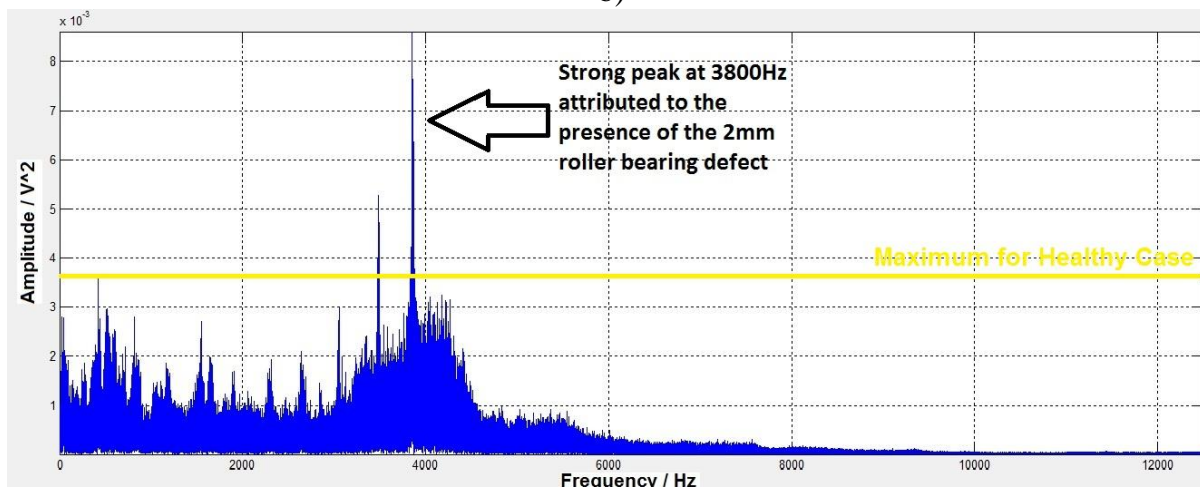
Figure 14: a) Power spectrum of the healthy axle bearing and b) power spectrum of the faulty axle bearing containing a 2 mm roller defect.

By converting the time-domain signal into frequency-domain using Fast Fourier Transform (FFT) it is evident that for the faulty axle bearing a considerably strong peak appears in the power spectrum plot in figure 14b at approximately 3800 Hz. This peak also exists in the healthy axle bearing power spectrum in figure 14a but its magnitude is significantly lower. The repeated measurements carried out on both axle bearings indicated the persistence of the strong peak at 3900 Hz in the power spectrum of the signal for the defective axle bearing. This suggests that the significant increase in the 3800 Hz peak is likely to be associated with the roller defect present. However, it is not possible to evaluate the severity of the defect using the vibration measurements and through this analysis it is only possible to qualitatively evaluate the possible presence of a problem in the axle bearing under evaluation.

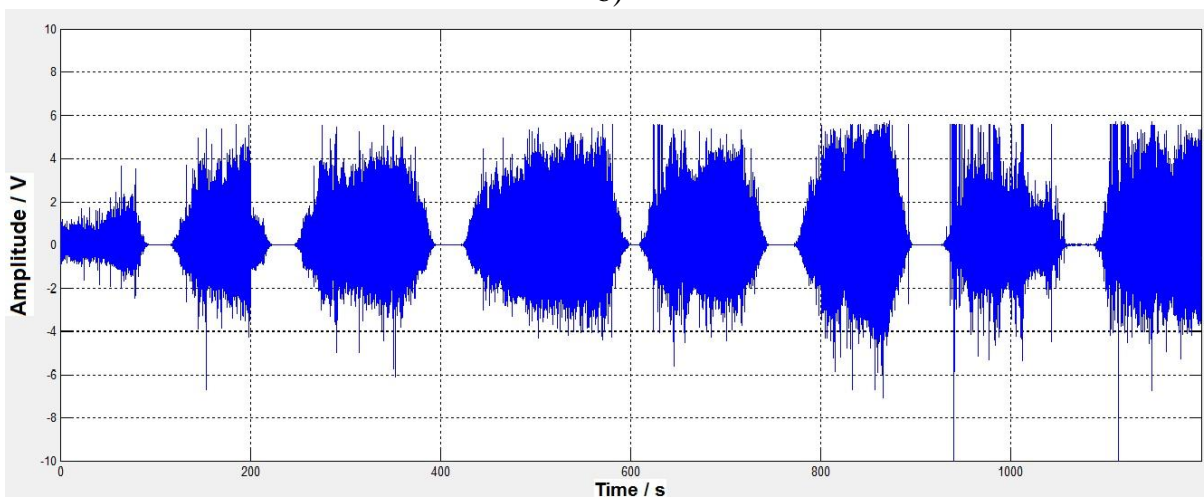
Figure 15: a) Raw vibration data for healthy wheel and b) raw vibration data for defective wheel.

During the EMU trials in Portugal, acceleration measurements were collected for a wheel free of defects and a defective wheel containing shelling on the tread surface. The average train speed during tests was 75 km/h or 20.70 m/sec. The plot in figure 15a shows the raw vibration signal for the healthy wheel and 15b for the wheel in the deteriorated condition. Although the raw vibration plots generally differ in each wheel condition, it is not sufficient to arrive in a safe conclusion since the vibration data will differ from wheel to wheel regardless of their actual condition. It is crucial to be able to identify from the vibration measurements the origin of the fault. A flat or spalling should give different pattern from a bearing defect. Approaches based on peak to peak levels alone should be considered more dependable on the measurement conditions as load, speed, wheel profile quality and rail track quality.

Thus it is impossible to assess the severity of the defects present on the damaged wheel based on the raw data alone. For this reason further analysis was carried out using moving RMS, spectral analysis (FFT) of the raw signal and spectral analysis of the demodulated signal (FFT of the envelope of the signal).

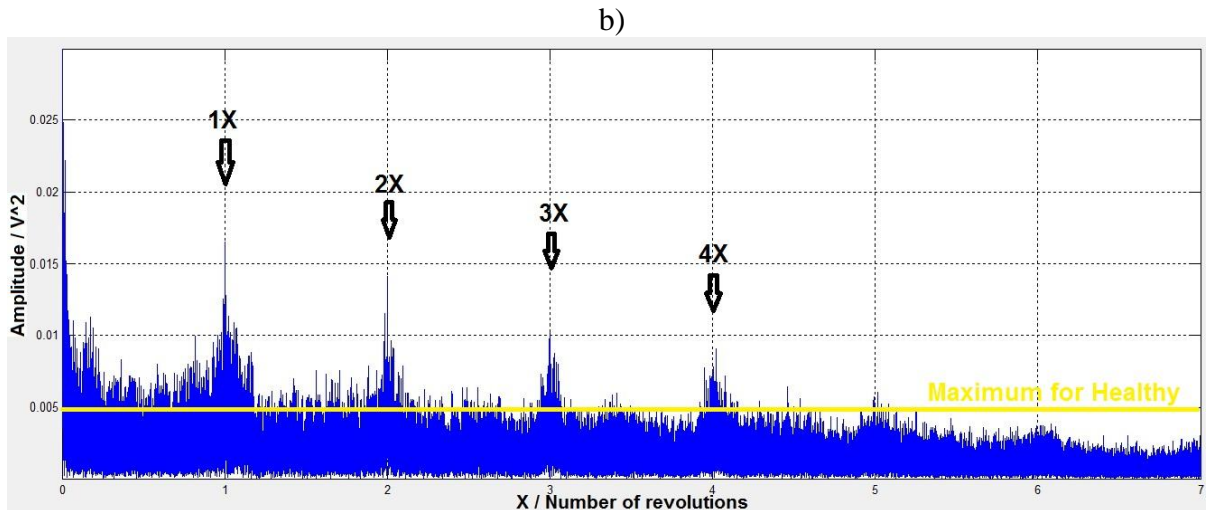
Figure 18: a) Demodulated power spectrum for the healthy wheel showing no harmonics and b) demodulated power spectrum for the defective wheel showing clear evidence of multiple harmonics up to 4X. Note also the significant difference in the amplitude of the two signals.

Since shelling is expected to impact on the rail during each wheel revolutions or 1X the low frequency power spectrum and harmonics should be employed in order to identify this specific fault. The plots in figure 18 show the low frequency demodulated power spectrum of the acceleration signal up to 7 wheel revolutions (7X) for both the healthy (18a) and defective (18b) wheels. The demodulated power spectrum signal in figure 18b shows clearly the 1X peak and associated harmonics up to 4X for the defective wheel indicating the presence of a fault on the tread. In the plot of figure 18a these harmonics are not present for the healthy wheel. Thus, this analysis clearly identifies wheel faults and a clear separation between healthy and deteriorated condition has been achieved. It is possible to relate the result directly to any wheel problems present thanks to the multiple harmonics showing up if the train speed is taken into account.
