Wind Turbine Tower Collapse Cases: A Historical Overview

Ma, Yang; Martinez-Vazquez, Pedro; Baniotopoulos, Charalampos

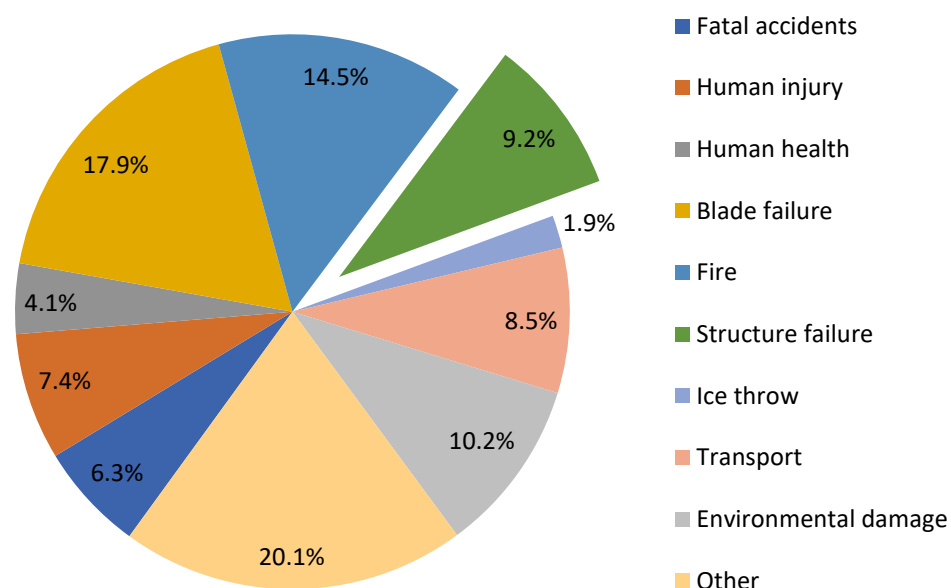
Fig. 1 Failure type distribution of wind turbine incidents recorded between 1980 – 2016 (CWIF, 2017)

Fig. 1 shows that blade failure concentrates the maximum percentage of collapse cases, arguably due to the fact that this failure type often derives in chain reactions. Blades are made up of composite fibre having stable performance against aerodynamic forces although depending highly on the quality of their manufacturing. Blades may deform flapwise or be subject to significant lagged and torsional deformations, hence exhibiting ductile performance. Their connection components however tend to be exposed to large deformation occurring at high rates over time which makes them susceptible to fracture (Hau, 2013).
